Mitchell Elementary School

Civil Assessment

Nitsch Engineering has performed research of the existing site conditions for the Mitchell School at 187 Brookline Street in Needham, Massachusetts. Nitsch Engineering also conducted a site visit on April 19, 2011 to observe the overall site, take pictures and provide a preliminary outline of short and long term needs for the school. Nitsch Engineering also included anticipated site permitting requirements for the Mitchell School for any proposed site work.

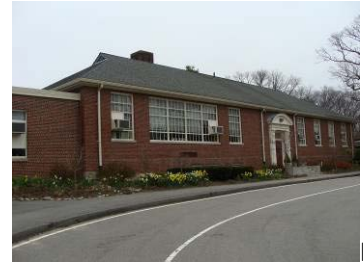
Image 1

The original cast in place concrete foundation, which varies in height and accessibility to a basement storage area and mechanical room, is in good condition. Some spalling of the concrete has occurred on the West side where asphalt pavement has been poured up to the concrete wall and aggregate is visible along much of the foundation wall.

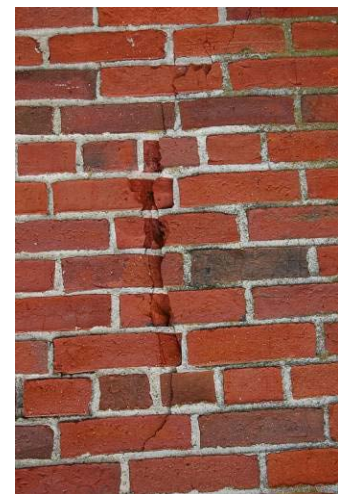
Image 8

The exterior brick walls in general are in fair condition with some areas in poor condition. The original structure shows the least deterioration with a small amount of efflorescence and brick decay. Regrouting and repointing is needed in various areas and the expansion joint between the 1958 kindergarten addition and the original building is in need of repair with the appropriate expansion joint materials. The 1958 addition shows some efflorescence and fungal growth in several areas and there are signs of brick movement in some locations (Image 5). There are areas where the bricks have cracked, or have damage that appears to be from an impact load (Image 7 and 8).

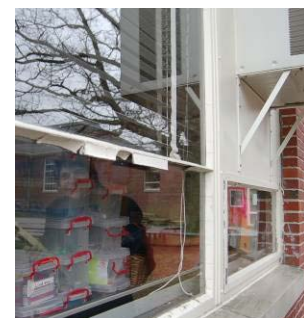
Image 9

Windows located in the original building are steel sash with hopper style venting at both the top and bottom of the window units. The glazing is single pane non insulated glass and is not energy efficient; this is typical throughout the building. In the 1958 addition the windows are a mix of steel frame and wood frame, both are in need of maintenance and repair. Several of the wood frame windows are located close to grade and show signs of wood rot. The 1968 addition metal frame windows are rusting and allowing water to enter the window frame.

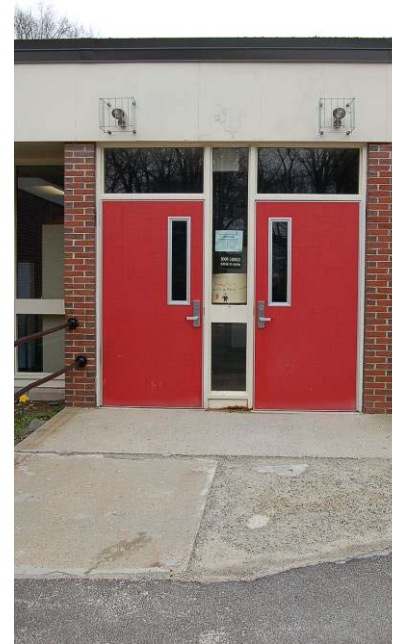
Image 17
Tower Ave Entrance

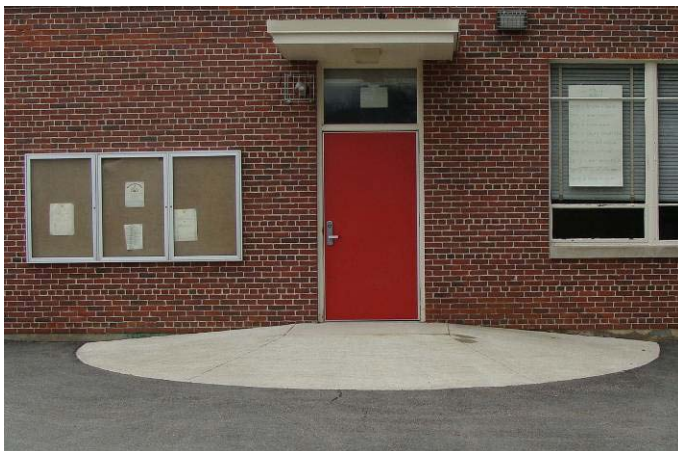
Image 18: Entrance to Kindergarten Rooms

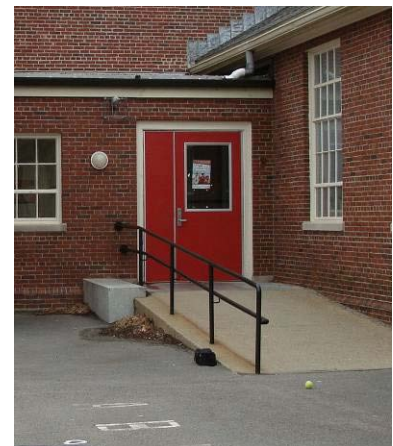
Image 19
Ramp on West Side of
building

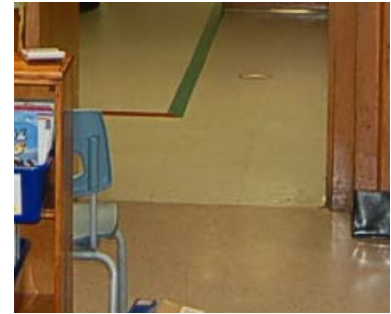
Image 23

The main entrance flooring and the adjacent corridor and classrooms of the 1958 addition has a VCT and AT flooring that is in good condition, the original flooring in this area was asphalt tile (per the construction documents). The VCT flooring varies throughout this area in color and age but appears to be in good condition (Image 23)

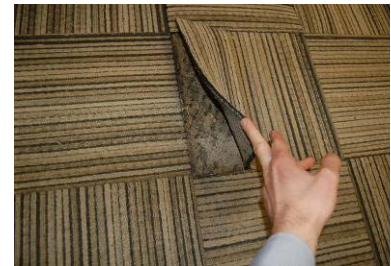
Image 24

The corridor of the 1968 addition has a VCT floor which is in good condition, and the restrooms in this area have 1x1 ceramic tile floor in good condition. The library flooring is carpet which is in good condition with the exception of the area in front of the entrance door where the carpet squares are "popping up" and creating a tripping hazard (Image 24).

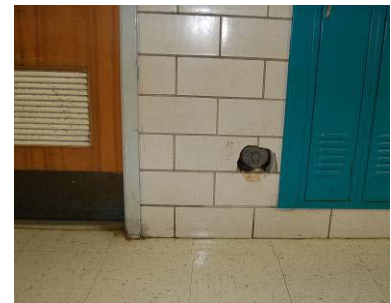
Image 25

are some obvious areas in need of repair as noted in Image 25.

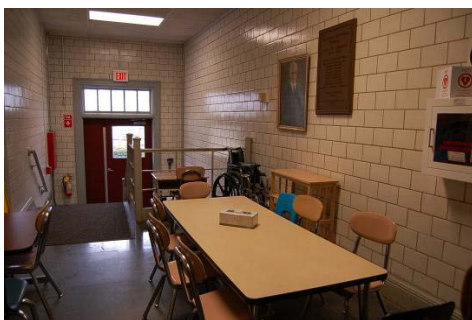
Image 37

Because the building does not feature automatic sprinklers, storage rooms, boiler rooms and other incidental use area should be separated from the remainder of the building with fire resistant construction to contain fires that start in unintended areas. At the Mitchell School an open stairway that is an emergency exit path is open to the storage room and boiler room below (Image 36), this same stairway is also used as an area for tutoring and small group lunches (Image 37).

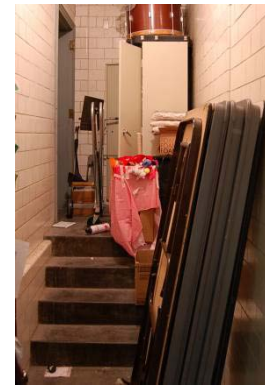
Image 34

Stairs are required to have guard rails at 42" high and baluster openings that do not exceed 4". The stairways noted in Images 34 and 36 do not conform to these requirements. Additionally handrails are required to extend beyond the top and bottom risers on both sides of the stairway. Handrails are also required on both sides of the interior ramps.

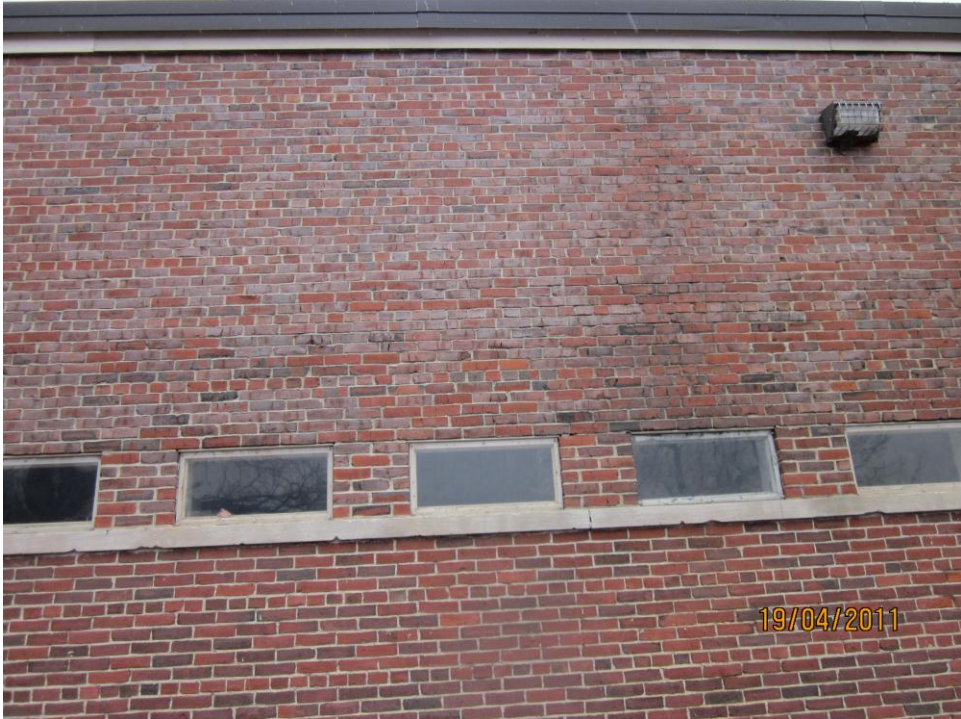
The original building and additions are in sound structural condition; there is no evidence of any distress or settlement at the foundations. The exterior walls, other than some localized conditions (Refer to Photos 1-3) where brick is spalling and mortar is decaying at joints on the wall at the north end of the original building (Refer to Photo 4) are in reasonable condition.

Photo 1: Exterior wall conditions.

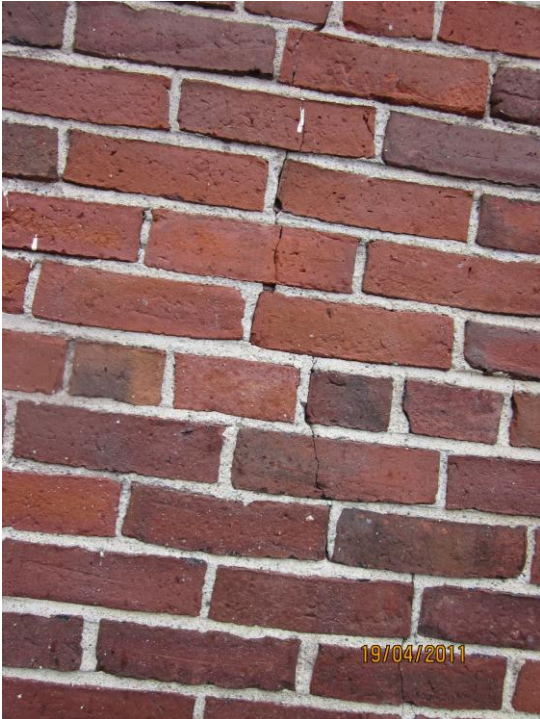
Photo 2: Exterior wall conditions.

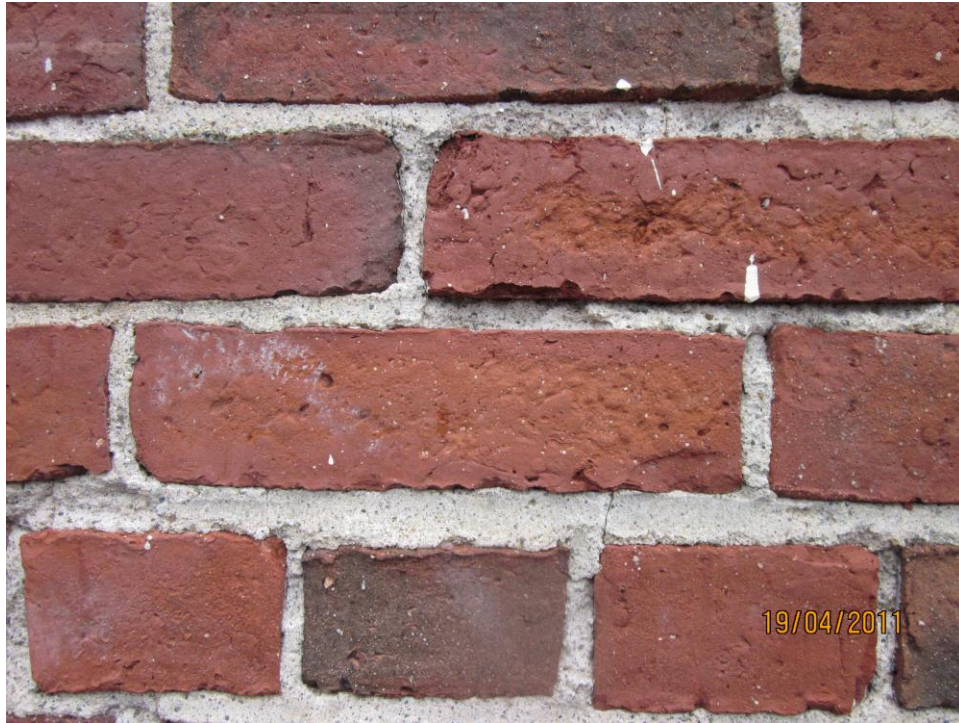
Photo 3: Exterior wall conditions.

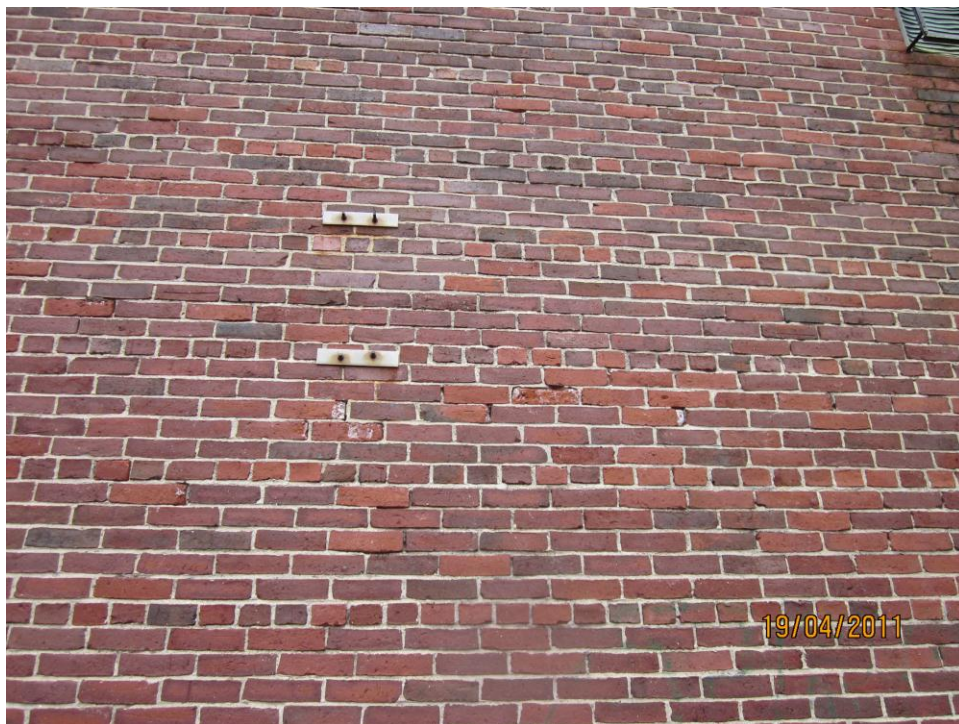
Photo 4: Decaying mortar at joints on north end wall of original building.

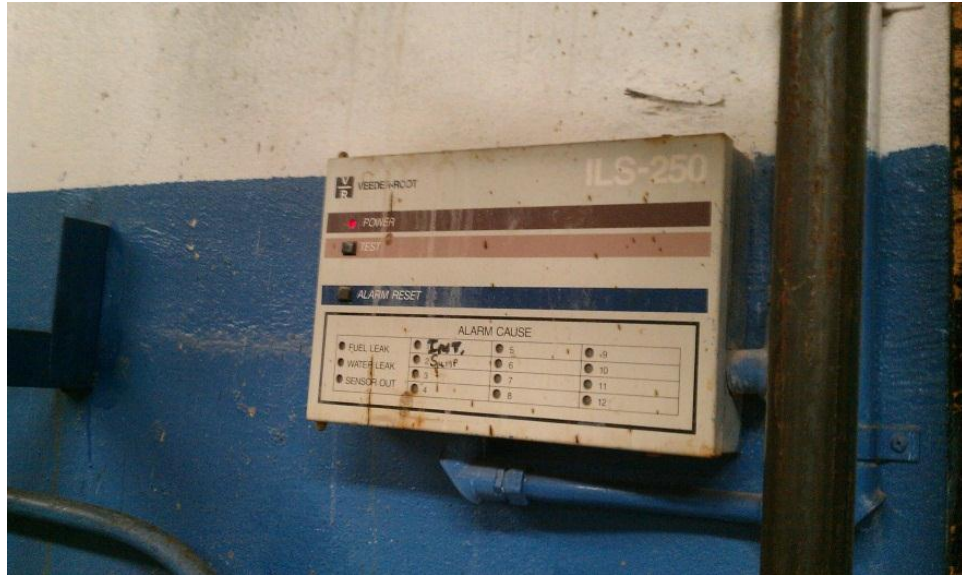
Old Veder-Root Tank Monitoring System

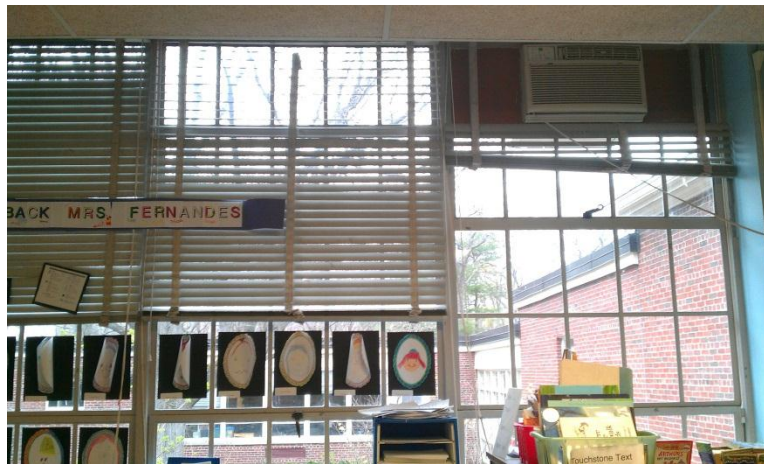
Window Air Conditioner Installed In Operable Window Space

- c) **Cooling:** If cooling is desired in the school, a new centralized cooling system should be considered. Currently, window air conditioners are putting a tremendous strain on the existing electrical system and should be removed entirely.

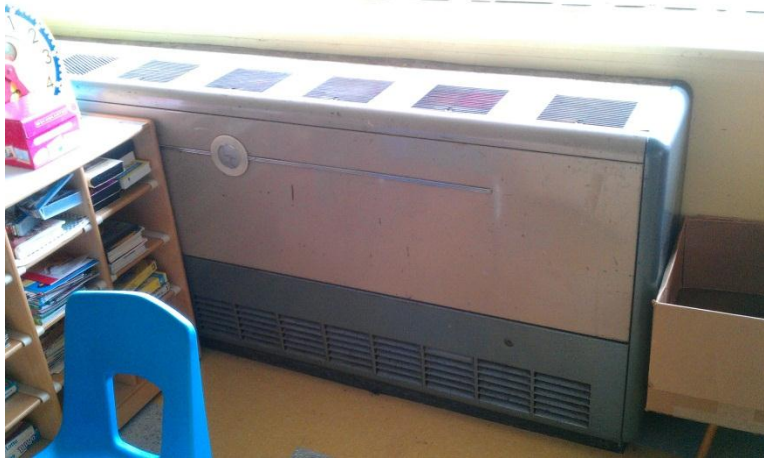
Very Old Classroom unit Ventilator

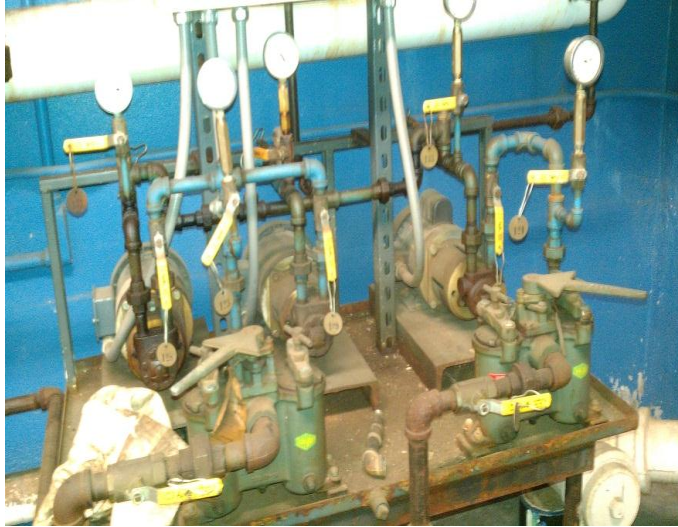
- b) Fuel Oil System: The capacity of the fuel oil system appears to be adequate. The condition of the underground storage tank and fuel oil distribution system is questionable and should be replaced with a new tank of equal storage capacity. The leak detection system is also in need of replacement. In general, the entire fuel oil system needs to be replaced. Conversion to natural gas should be seriously considered if gas service becomes available.

Fuel Oil Pumps & Piping

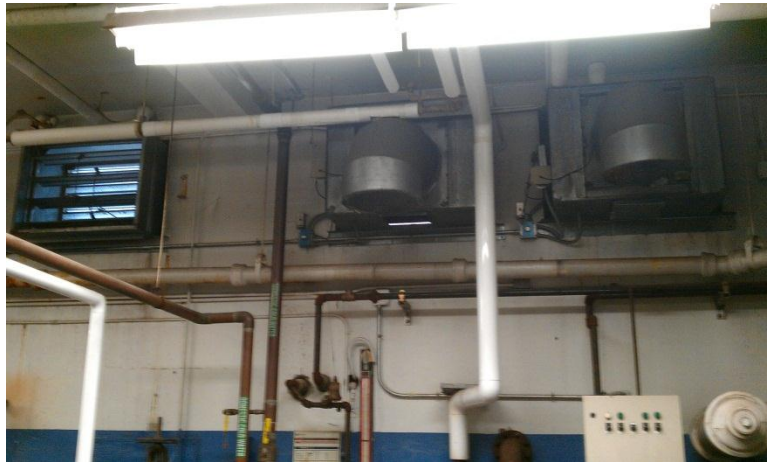
- a. Main Steam Boilers: The boiler room was observed to get its combustion air and ventilation mechanically from two intake fans with motorized dampers and intake louvers mounted high on the wall combined with a motorized damper for pressure relief. The quantity of outdoor air should be investigated to ensure the proper amount is being supplied to satisfy mechanical codes.

Boiler Room Ventilation/Combustion Air Intake & Exhaust

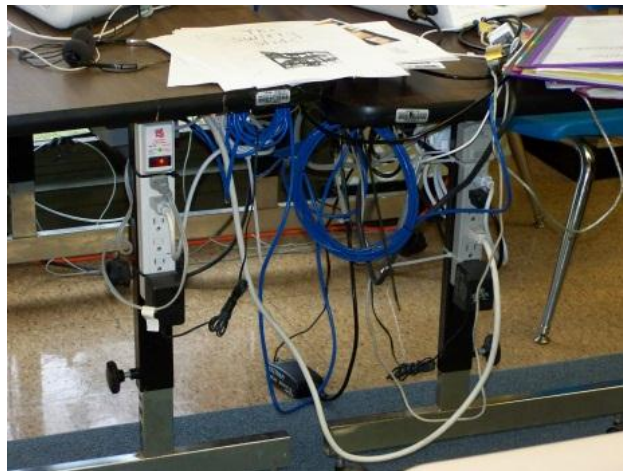
9. Technology distribution is minimal compared to modern classrooms. The existing technology in the building appears to be outdated and upgrading the existing is questionable.
10. Receptacle quantities are not adequate for this application as evidenced by the quantity of extension cords and power strips in the classrooms.

Photo 9: Typical Technology Receptacle
