Mitchell Elementary School

Civil Assessment

Nitsch Engineering has performed research of the existing site conditions for the Mitchell School at 187 Brookline Street in Needham, Massachusetts. Nitsch Engineering also conducted a site visit on April 19, 2011 to observe the overall site, take pictures and provide a preliminary outline of short and long term needs for the school. Nitsch Engineering also included anticipated site permitting requirements for the Mitchell School for any proposed site work.

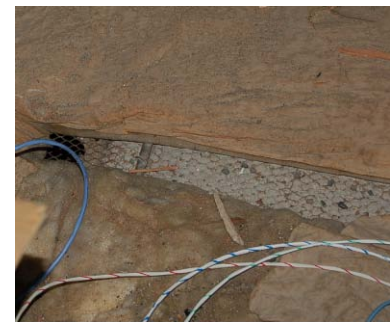
Image 22

One of the more significant issues at the Mitchell School is the lack of insulation in the attic space of the 1949 building. There was approximately 2" to 3" of fiberglass batt insulation observed directly on top of the plaster ceiling (Image 22). This insulation was inconsistent in many areas due to ductwork, piping, electrical conduit penetrating through the ceiling. It was evident that some of the insulation had been moved, most likely by various workers over the years accessing the space to maintain, repair and upgrade the building systems. The insulation system was inadequate as originally installed and is a difficult system to maintain continuity. Our recommendation is to shift the location of the thermal envelope to the roof level to provide a continuous thermal envelope and insulate the transition from the wall to the roof. This system should still provide for venting of the asphalt shingle roof system.

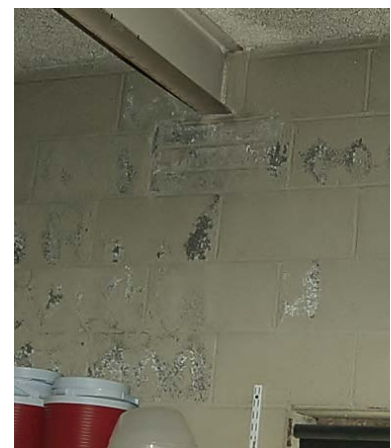
Image 26

The interior face of exterior walls in general are in good condition with the exception of the areas noted above where mold and dampness were noticeable on the exterior wall and may have caused damage on the interior face of the wall. The most noticeable example of this is in the 1958 storage room addition adjacent to the cafeteria (Image 26). Efflorescence was noticeable on the interior face of the cmu wall and there are cracks in the cmu wall above the window.

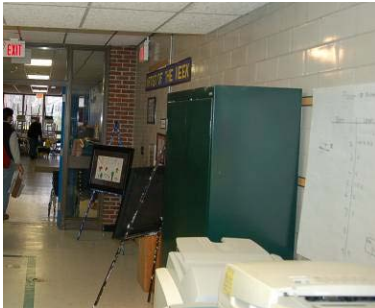
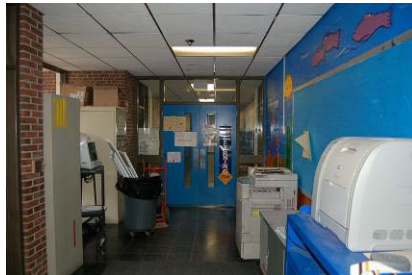
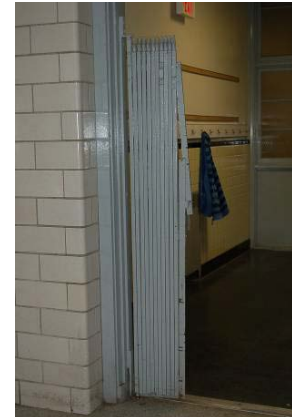
Exits and egress paths should be clear of storage, equipment, and protruding objects. During our visits hallways were used for both temporary and permanent storage of equipment and recycle bins, as well as for student tutoring. We also noted a collapsible gate used to close off a portion of the school. This gate should be removed; if securing this area is required doors with emergency egress hardware should be installed to provide continuous access to the emergency exits. Exit signs should be lit and exit doors should not be blocked.

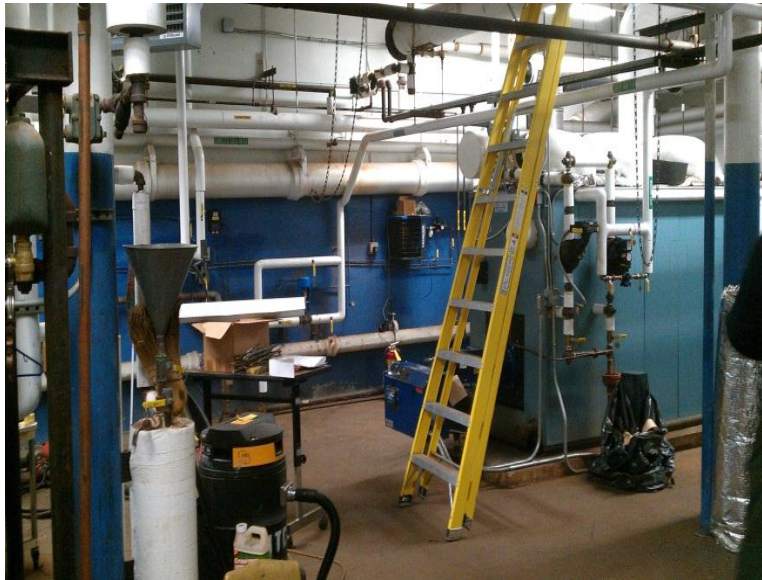
Boiler Room

1. **Main Steam Boilers:** The existing building HVAC system consists of two, cast iron, sectional, HB Smith low pressure steam boilers. Both boilers burn #2 fuel oil. Total heating capacity of both boilers is approximately 6,000 lbs/h of steam or 5,700 MBH.

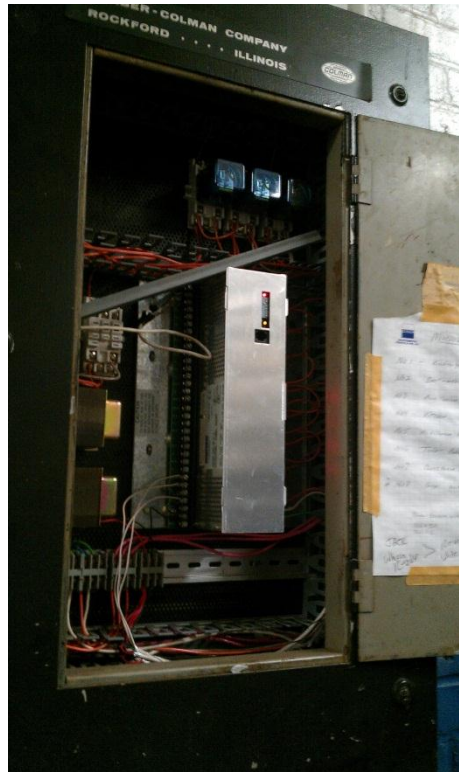
Barber-Colman Network 8000 DDC control System

6. **Piping:** The Mitchell school contains both steam and hydronic heating piping. The steam piping is from the original building construction in the late 1950's while the hydronic piping is from the late 1960's addition. Piping insulation in the boiler room appears to be newer, installed during the recommissioning project which took place 2 years ago.
7. **Controls:** The school currently uses a Barber Coleman Network 8000 Microzone DDC control system. This system was installed during the recommissioning project 2 years ago and is used to control all unit ventilators, finned tube radiators and air handling units throughout the school.

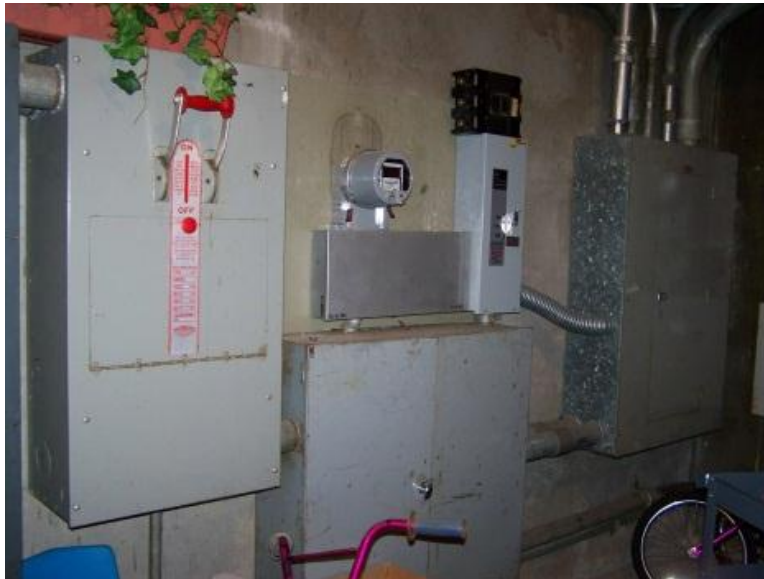
Main Service Equipment

1. The building is supplied by an underground electric service. In the basement the service is split into a metered 600Amp section and a metered 200Amp and 100Amp section. The building is served at 208Y/120 Volt, 3-phase, 4-wire, and the equipment appears to be the original service switches and panels. All panels are full with no spares or spaces.

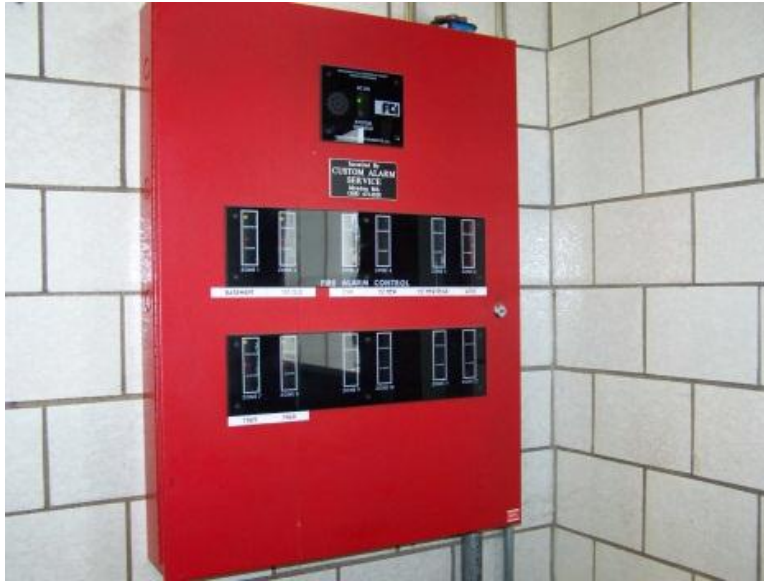
Main Fire Alarm Control Panel

3. The fire alarm system is a zoned, analog type system manufactured by FCI. This system is in fair condition. The fire alarm control panel is wall-mounted close to the main entrance and also serves as the annunciator. There is an existing fire alarm masterbox and Knox box located on the outside of the building. The system does not have any smoke detection, only heat detectors.

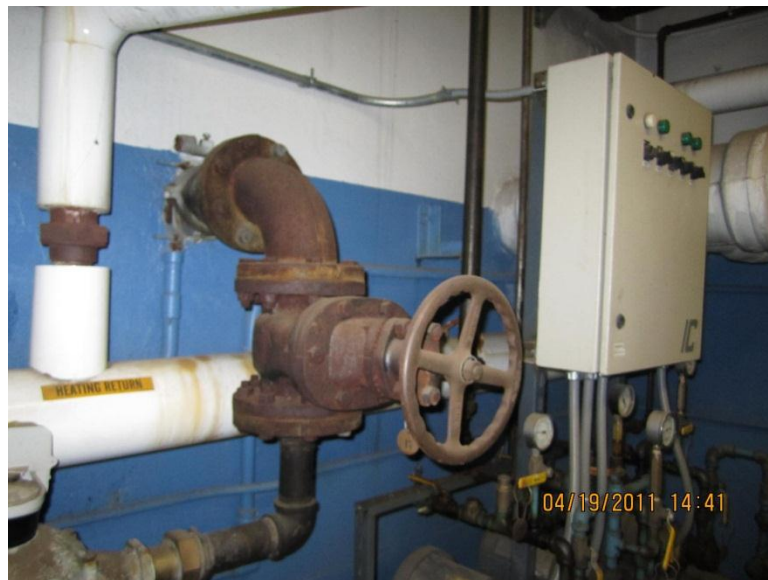
Water Service Entry

A four inch water service from Brookline Street enters the boiler room of the 1949 wing and appears to be original to the building's construction. The service stubs through the foundation wall overhead and has a flanged non-rising stem main shut-off valve.

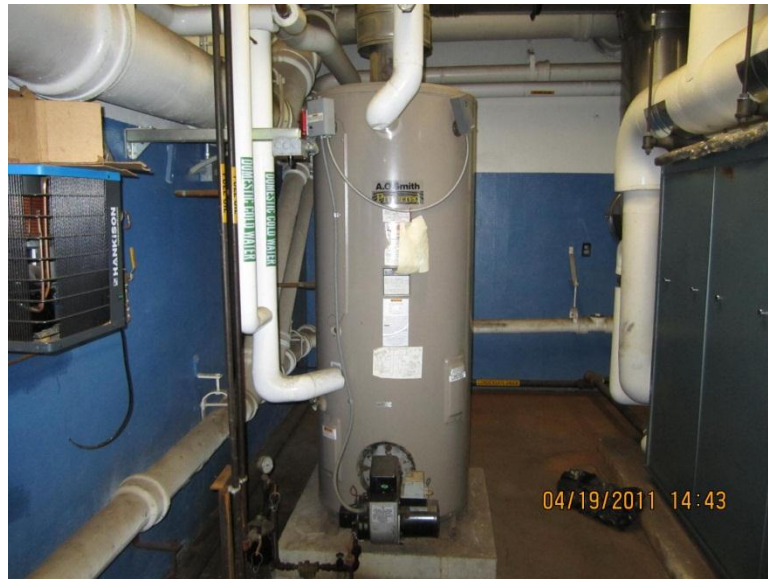
Domestic Water Heater

Domestic hot water is generated with an oil-fired storage water heater located in the boiler room. It is a vertical 84 gallon storage tank with insulation and jacket and front mounted 315 MBH burner assembly capable of a recovery capacity of about 264 gallons per hour based on nameplate data. It stores water at 120 degrees. The kitchen dishwasher has a local electric hot water booster.

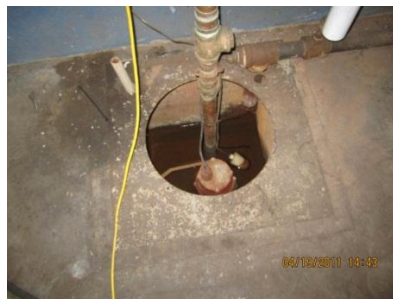
Boiler Room Sump Pump

The pipe materials appear to be cast iron with lead and oakum joints with some minor repairs made with no-hub jointed cast iron. With the exception of the boiler room drains, the entire facility appears to drain by gravity to the site sewer system. The boiler room is provided with a sump pump to lift waste to the sewer.

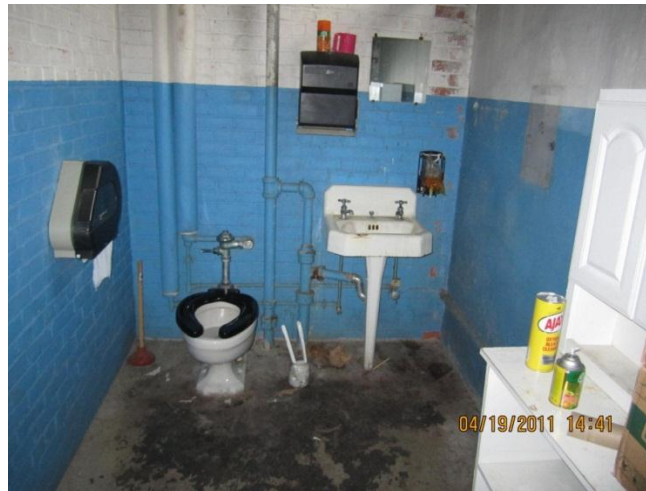
Basement Plumbing Fixtures

The plumbing fixtures in this facility consist mainly of floor mounted water closets and wall hung urinals with flushometer valves. The lavatory sinks are wall mounted. The majority of lavatory faucets are manual single operator metering type. A small complement of faucets are two lever. Janitor sinks appear to be trap-standard design or mop basins and have installed atmospheric vacuum breakers on the faucets. Drinking fountains are a combination of different styles.

The plumbing fixtures in this facility are 40 to 60 years old although some fixtures have been replaced in intervening years. Although they are functional, all fixtures should be updated to take advantage of water use reduction of low-consumption fixtures.
